WYLE LABS HUNTSVILLE ALA  
CAPSIZING/SWAMPING ACCIDENT INVESTIGATIONS FOR 1976 SEASON. (U)  
SEP 77 J BOWMAN, B SMITH

CAPSIZING/SWAMPING ACCIDENT INVESTIGATIONS FOR 1976 SEASON

16. Abstract From several hundred boating accidents, 28 were selected for in-depth investigations. These in-depth investigations were performed to augment and supplement the Coast Guard's data base acquired from the nationwide Boating Accident Reports (BARs). Unlike the several thousand BARs received annually, the in-depths contain details of the entire accident scenario and are used to assist in establishing national programs of loading related accident prevention by boat design and education.  This report summarizes the criteria for selection of those accidents to be investigated, the investigation procedures, and the accident data obtained for the 28 in-depth investigations. Each individual accident report is presented as Appendices to the summary report. The accident reports present information concerning the weather, the involved boat and occupants, causal factors, boat capacities and loading/powering information, and occupant actions/reactions prior to, during, and after the actual accident event.

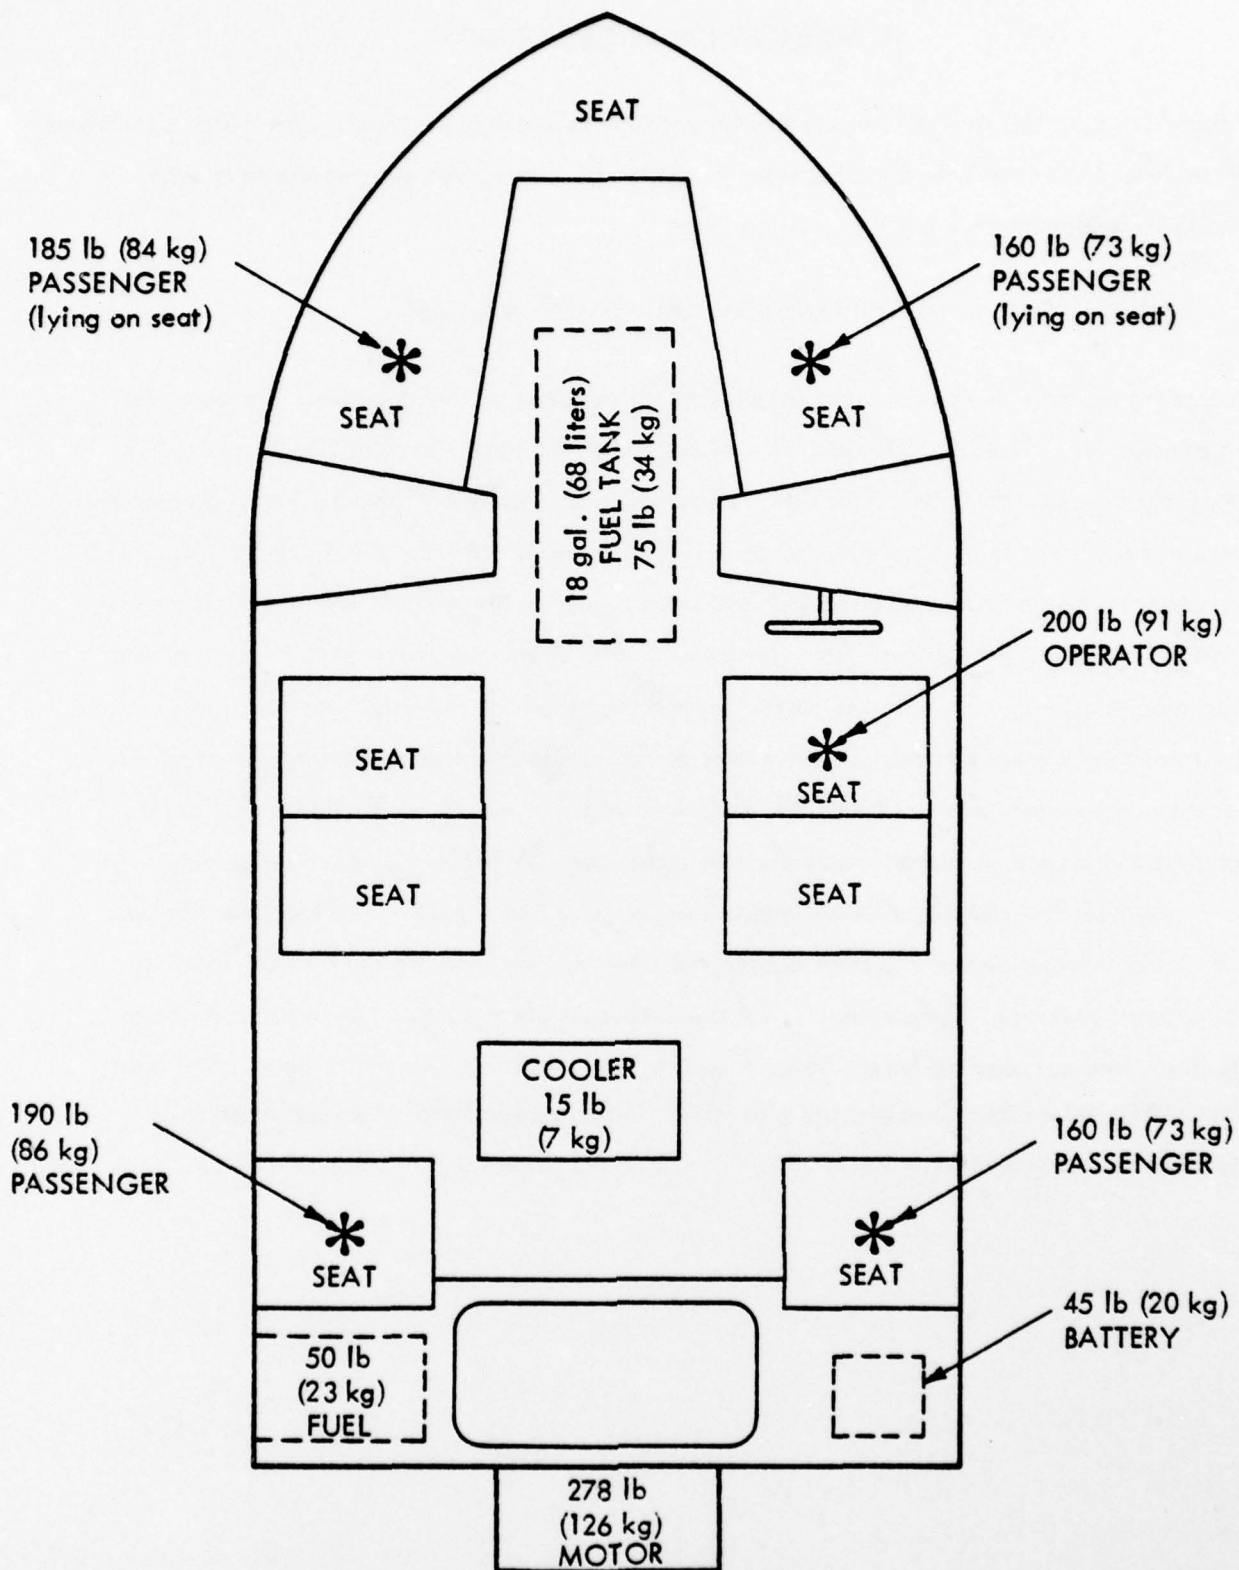
FIGURE 1. LOAD DISTRIBUTION AT TIME OF ACCIDENT

According to the estimated weight in the boat at the time of the accident, the boat was not overloaded. The load distribution was such that the boat was most likely running in a slightly bow low attitude. The tide was outgoing at the time of the accident, consequently there were current induced waves in the inlet. The wind was from the northeast, against the current, which produced wind induced waves. The wind and current was such that the waves in the inlet were not uniform (confused). The sheltered water on the inside of the inlet was relatively calm and the water beyond the mouth of the inlet was relatively calm. The transition distance from the calm water of the ocean and the rough water in the inlet was most likely very short. When the boat went into the mouth of the inlet, the water conditions changed in a short distance from light chops to 5-6 ft (1.5-1.8 m) waves. The boat rode over the crest of a wave, then bow first into the trough. The load distribution and forward momentum of the boat caused the bow to slice into the next wave flooding the forward passenger compartment. The bow freeboard was reduced by water weight to the point that succeeding waves broke over the bow swamping the entire boat. The boat most likely stayed in an upright position after flooding because of flotation material installed in the gunwales.

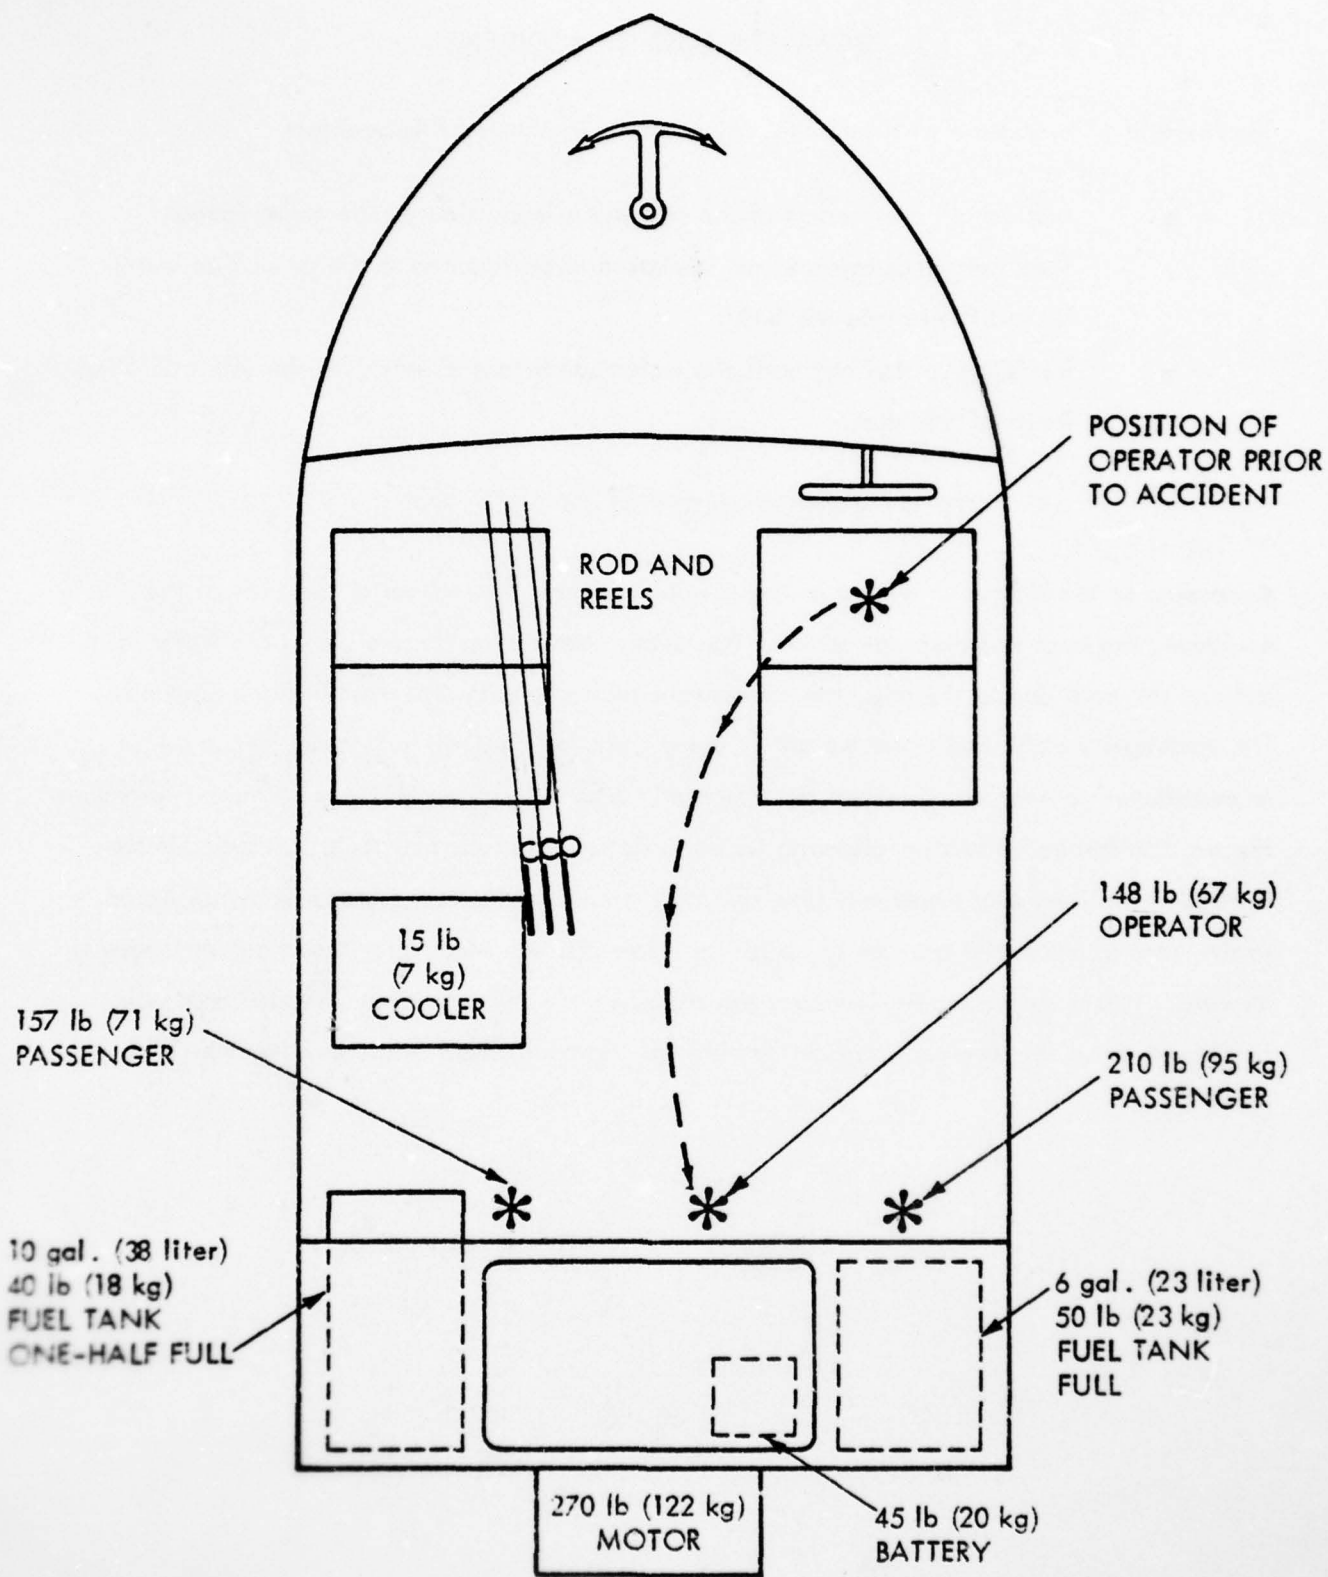
FIGURE 1. BOAT LOAD DISTRIBUTION AT TIME OF ACCIDENT

According to the estimated weight of the people and gear in the boat at the time of the accident, the boat was not overloaded. However, considering the weight of the water that entered the boat during the trip, the maximum weight capacity was most likely exceeded. The passenger weight and water weight in the aft section caused the transom freeboard to be reduced to near zero. When the operator moved aft, his weight was sufficient to reduce the transom freeboard to zero allowing water to flow freely into the boat. By the time the occupants realized that water was flowing into the boat, sufficient water had accumulated in the stern to cause the transom to remain in a low attitude even after the occupants moved forward. Water continued to flow over the transom until the aft section flooded and sank. Entrapped air in the bow section most likely kept the boat afloat in an upright, bow high attitude.
